Mobile Intel[®] Celeron[™] Processor at 466 MHz, 433 MHz, 400 MHz, 366 MHz, 333 MHz, 300 MHz, and 266 MHz Specification Update

Release Date: May 2001

Order Number: 244444-025

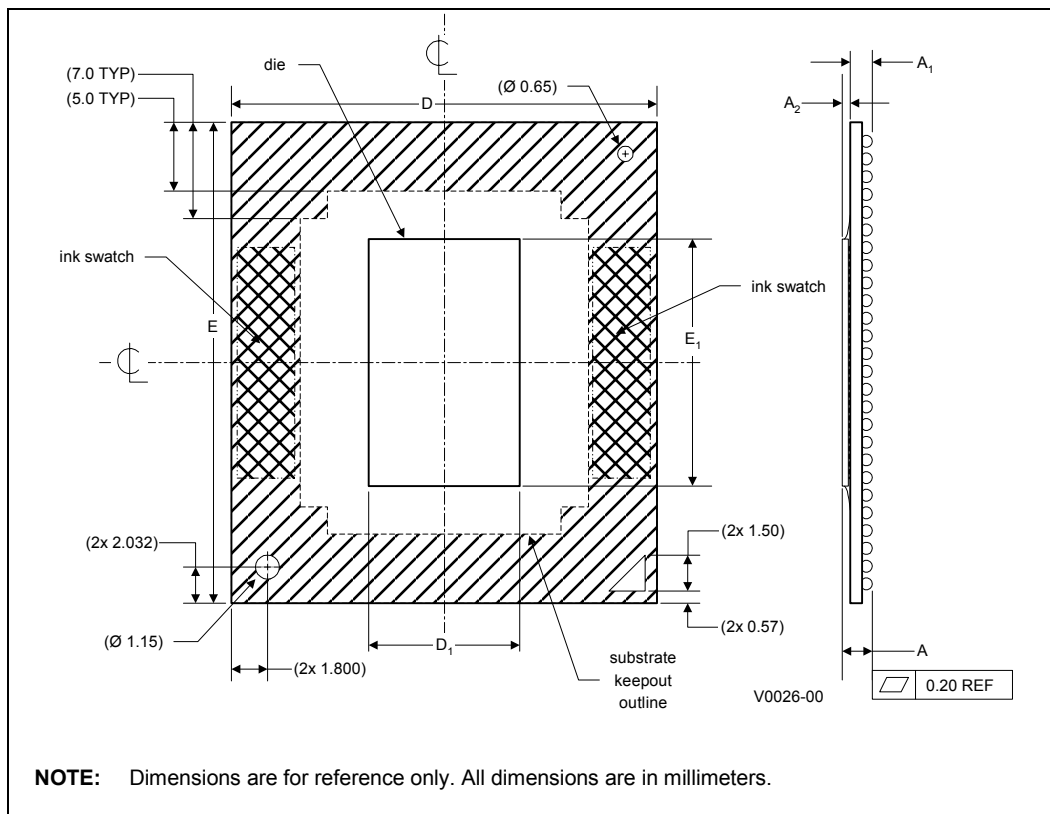
Figure 5.3. Surface-Mount BGA1 Package—Top and Side View

The following table and figures show the updated mechanical specifications for the BGA1 package, listed as Table 5.2, Figure 5.3 and 5.4, respectively, in the *Intel® Mobile Celeron™ Processor in BGA Package at 333 MHz, 300 MHz and 266 MHz* datasheet.

1. The number shown here is different from that in the 244444-004 version of this specification update. The maximum reference number is used.
